**Enbridge Line 6B MP 608 Pipeline Release
Marshall, Michigan**

**Permanent Recovery of Submerged Oil and Oil-Contaminated
Sediments at Priority Locations**

Submerged Oil Recovery Summary Report

**Enbridge Energy
October 29, 2010**

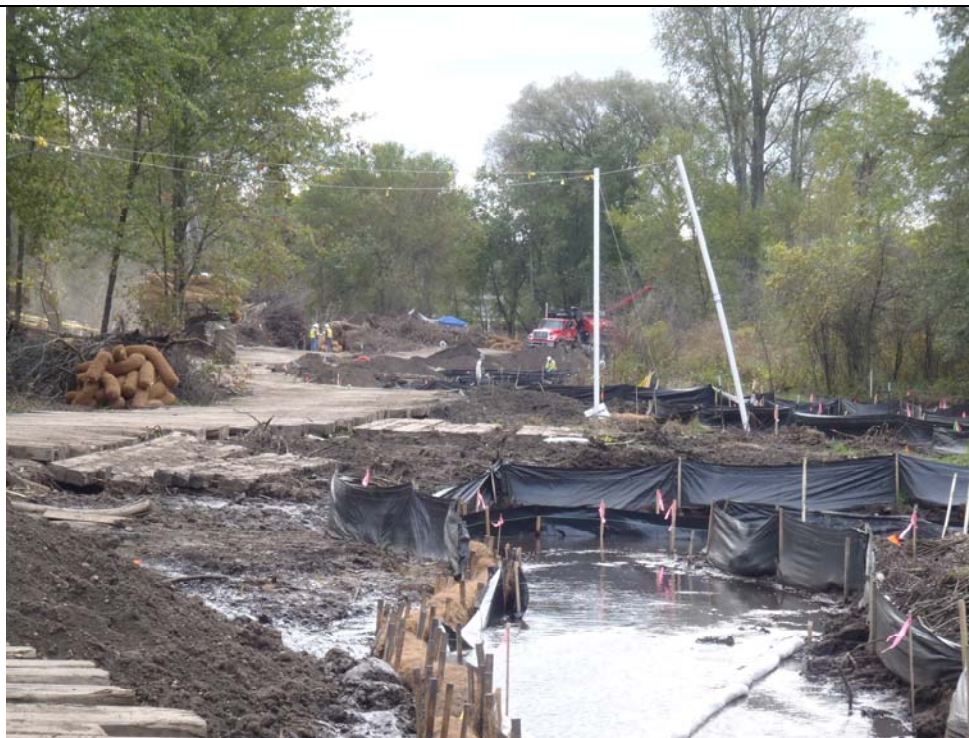
PHOTOGRAPH LOG
Photograph 1**Project Name:**
Enbridge Line 6B
Submerged Oil Task Force**Mile Post:**
Talmadge Creek – Source
Area to I-69**Date:**
9/25/10**Description:**
Recovery activities in
progress**View Direction:**
Facing north

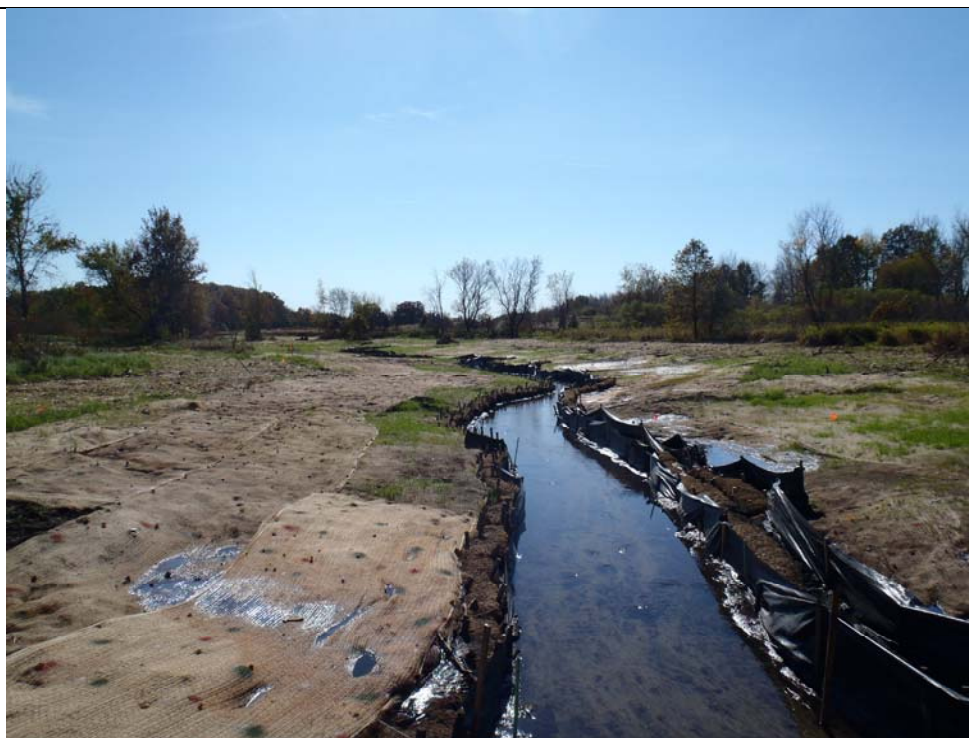
PHOTOGRAPH LOG
Photograph 2**Project Name:**
Enbridge Line 6B
Submerged Oil Task Force**Mile Post:**
Talmadge Creek – Source
Area to I-69**Date:**
10/17/10**Description:**
Post Recovery – Recovery
complete**View Direction:**
Facing north

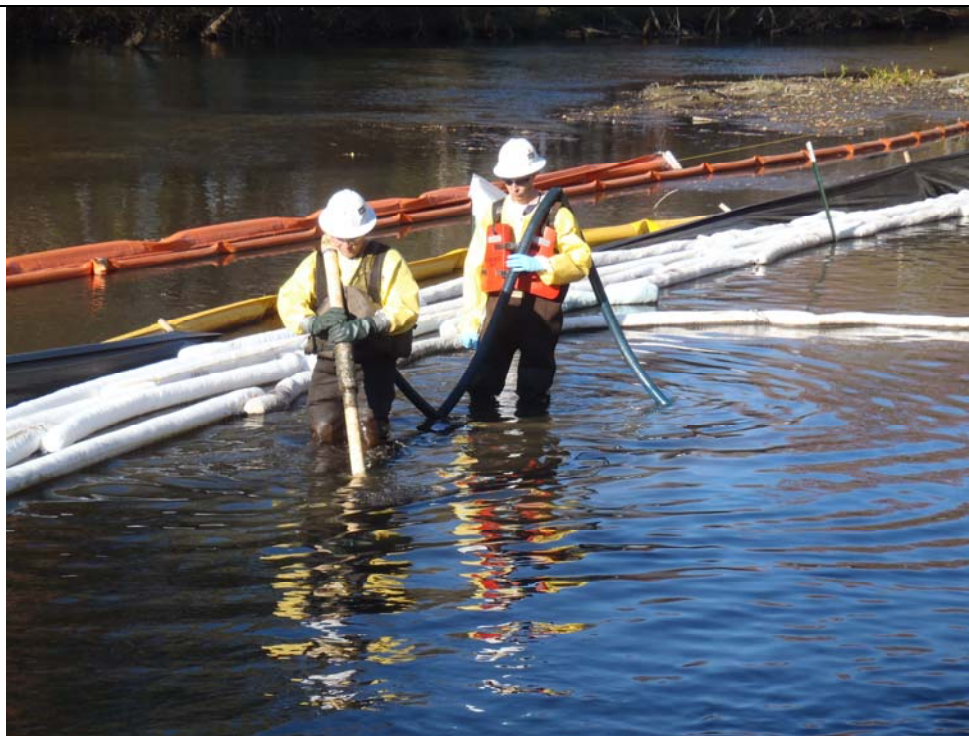
Description:Recovery activities in
progress**View Direction:**

Facing south

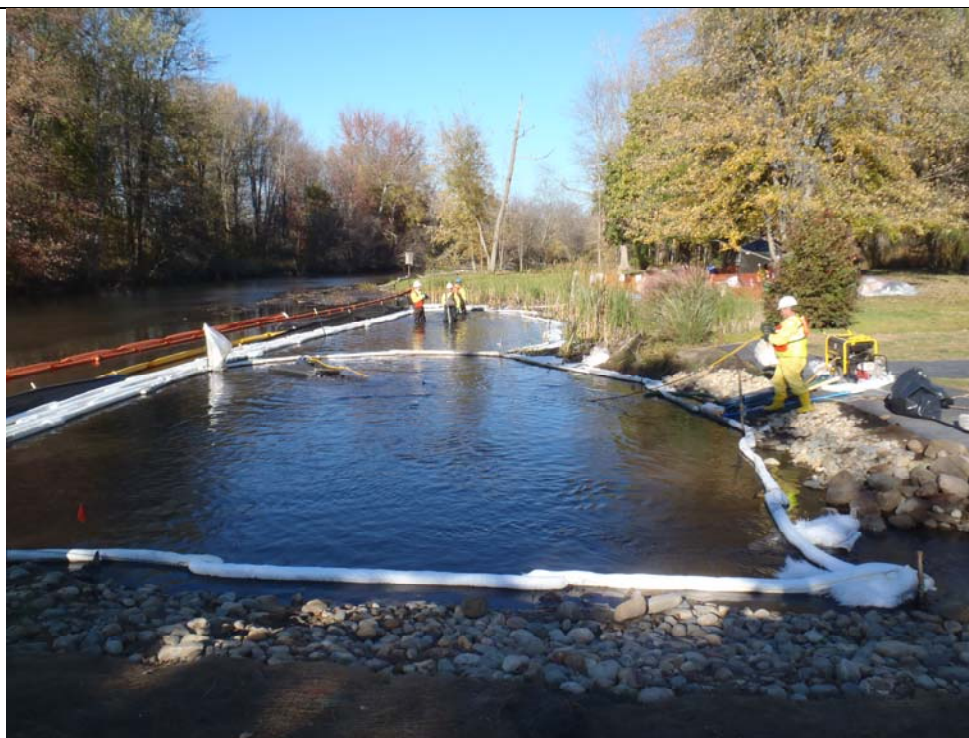
PHOTOGRAPH LOG
Photograph 4**Project Name:**Enbridge Line 6B
Submerged Oil Task Force**Mile Post:**Talmadge Creek –
Confluence**Date:**

Description:Recovery activities in
progress**View Direction:**

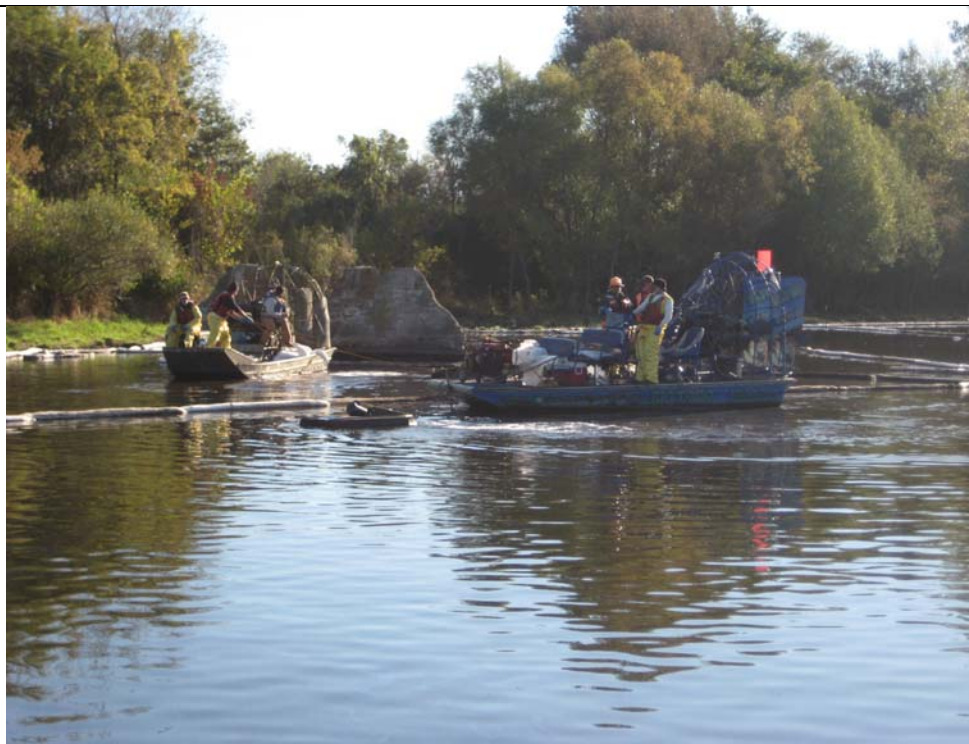
Description:
Recovery activities in
progress – aeration

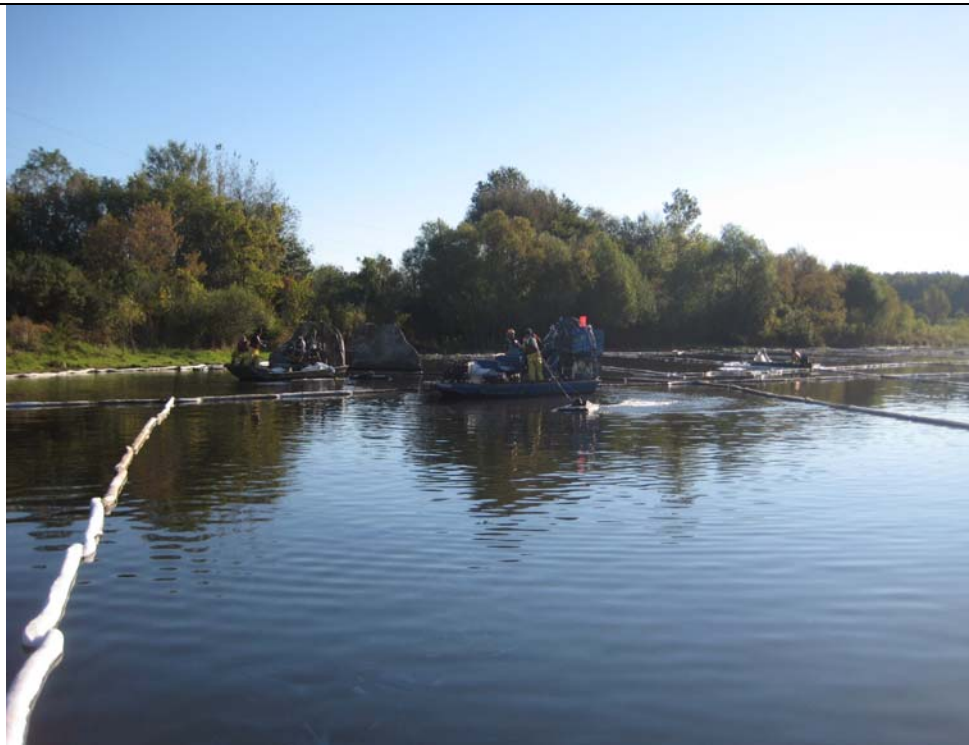
Photograph 2

Description:
Recovery activities in
progress - aeration

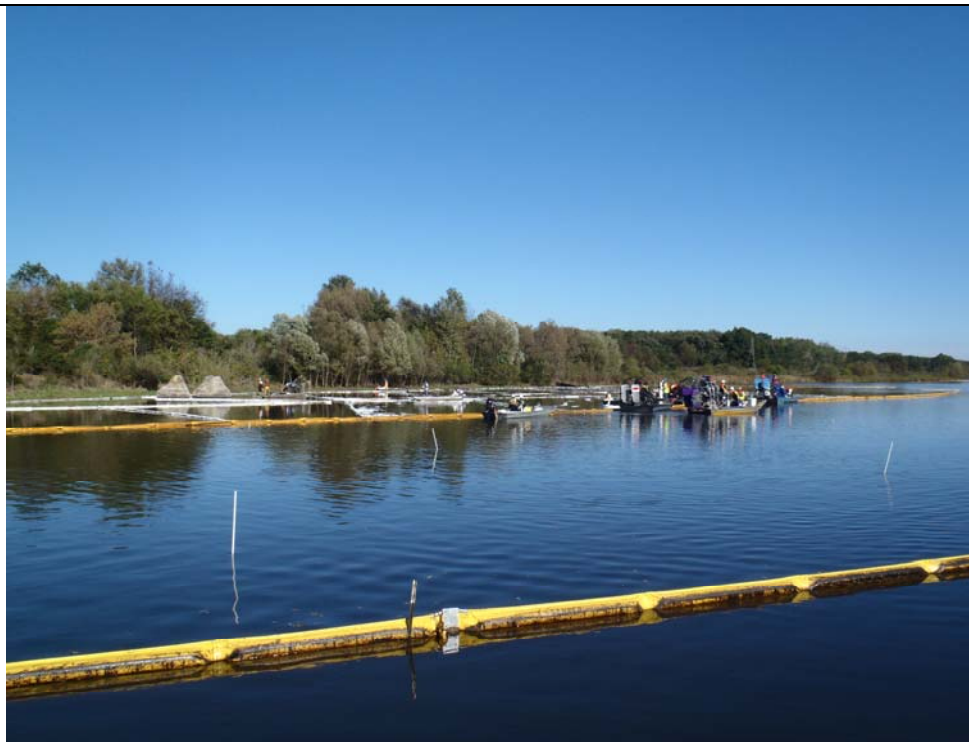
PHOTOGRAPH LOG
Photograph 3

Description:
Post Recovery activities –
removing boom and other
containment

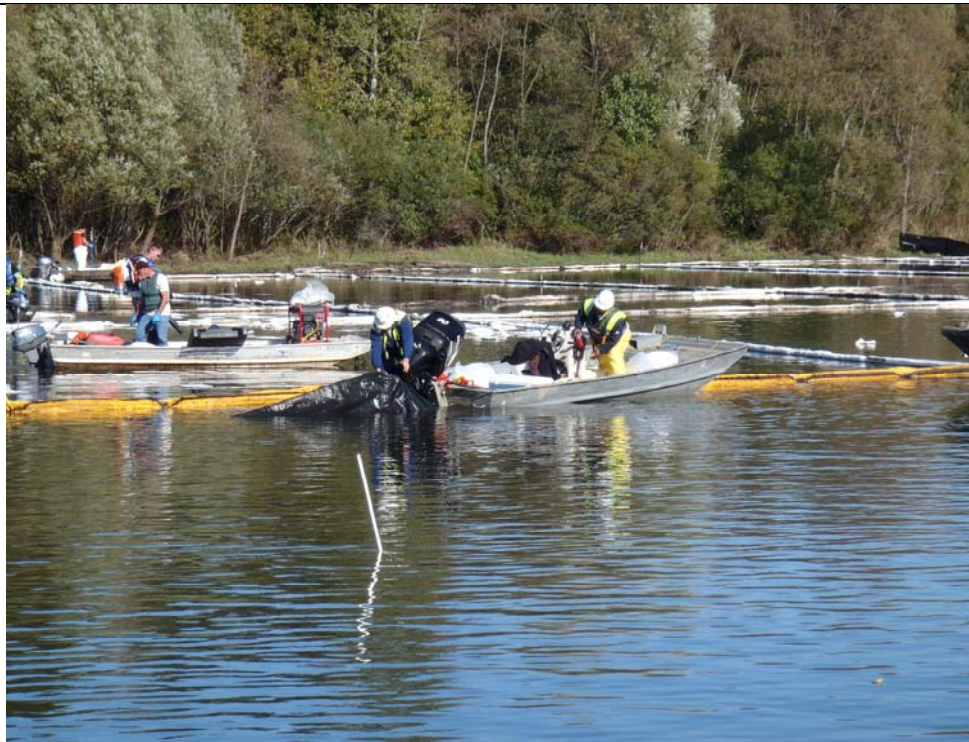
**PHOTOGRAPH LOG**
Photograph 4

Description:
Post recovery activities –
removing boom and other
containment

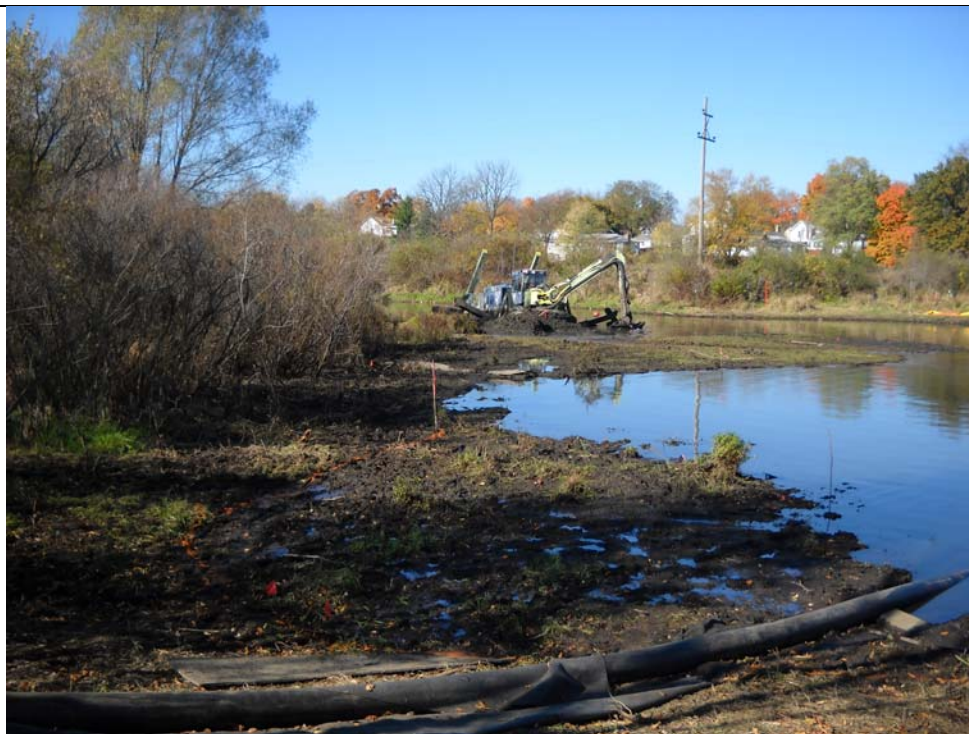
Description:
Recovery activities in progress – Amphibex dredging in cove near peninsula

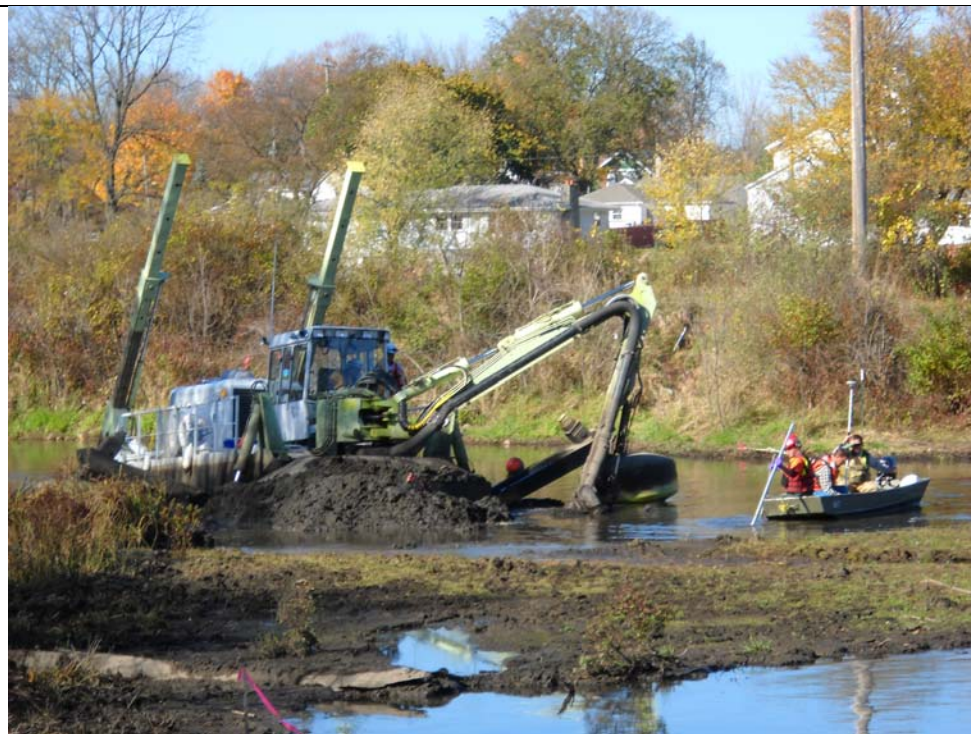
PHOTOGRAPH LOG
Photograph 3

Description:
Recovery activities in progress – Amphibex dredging in cove near peninsula

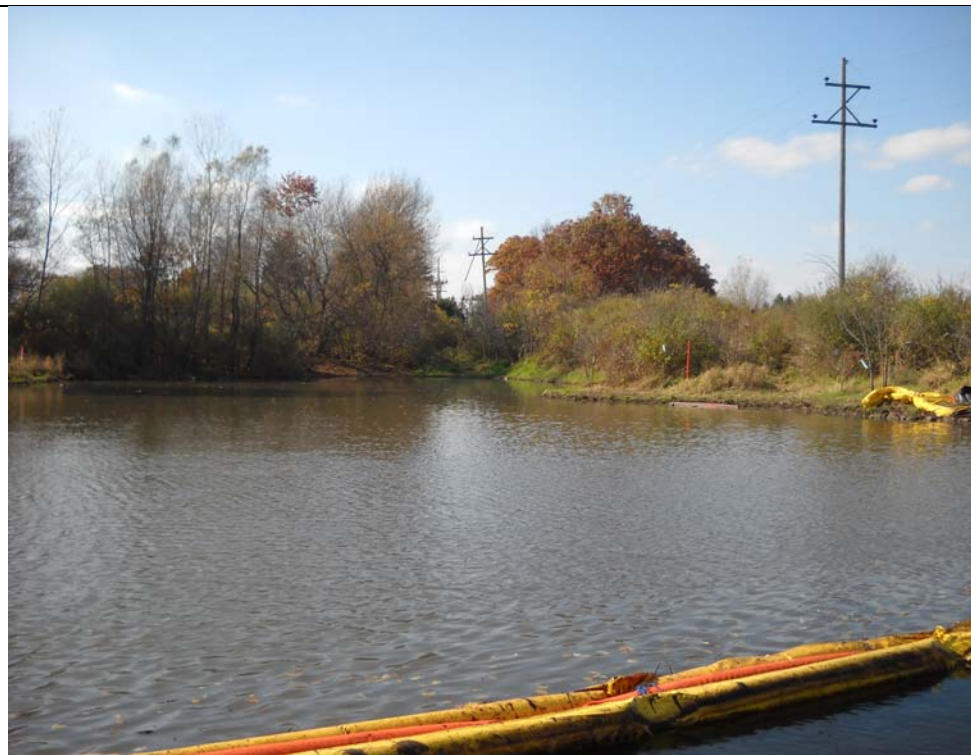
Photograph 5

Description:
Recovery activities
complete – Dredging
complete

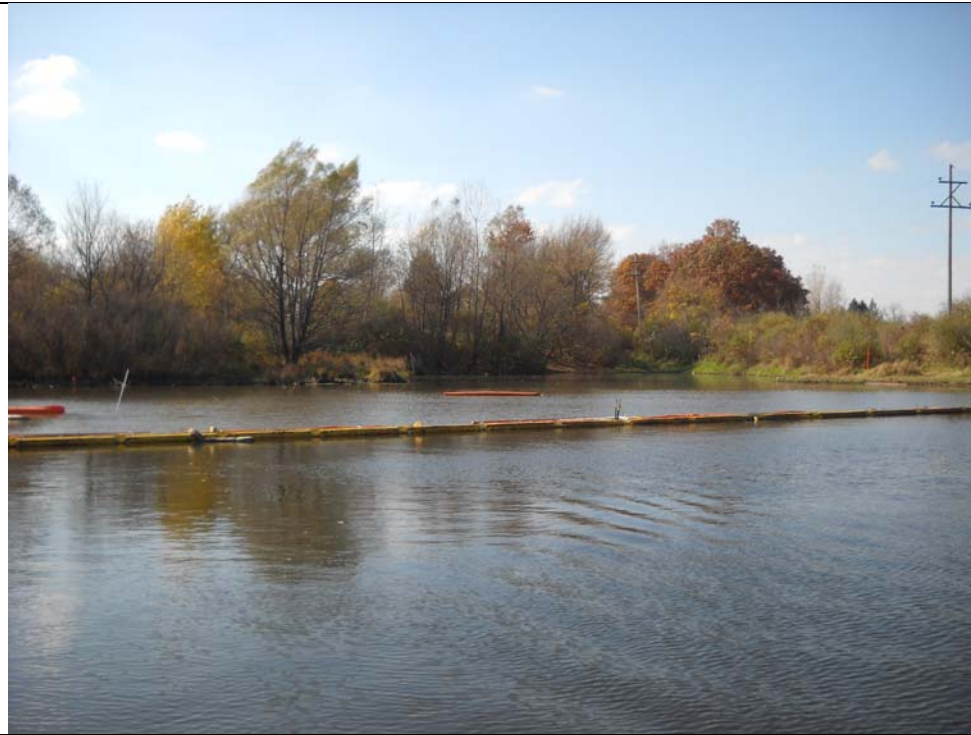
Photograph 6

Description:
Recovery activities
complete – Dredging
complete

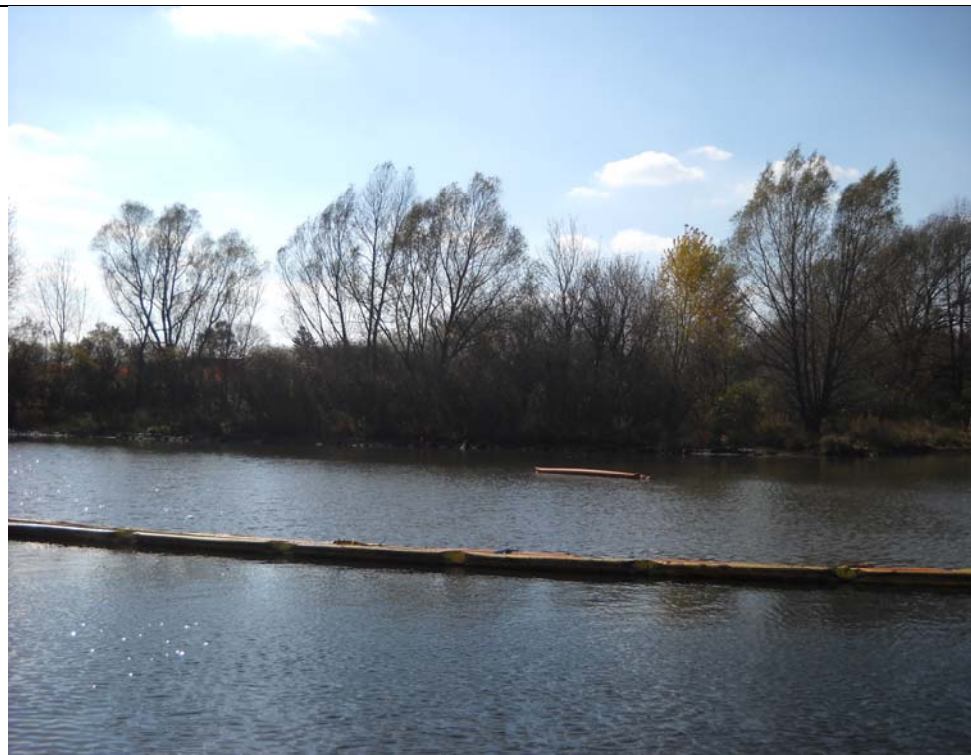
Photograph 7

Description:
Recovery activities
complete – Dredging
complete

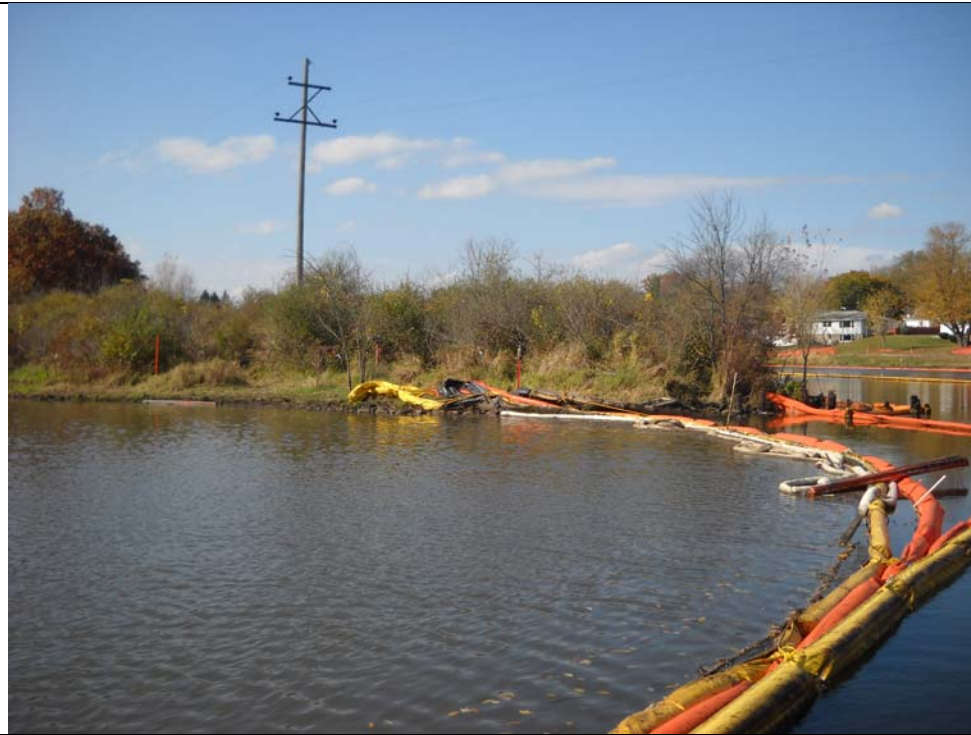
Photograph 8

Description:
Recovery activities
complete – Dredging
complete

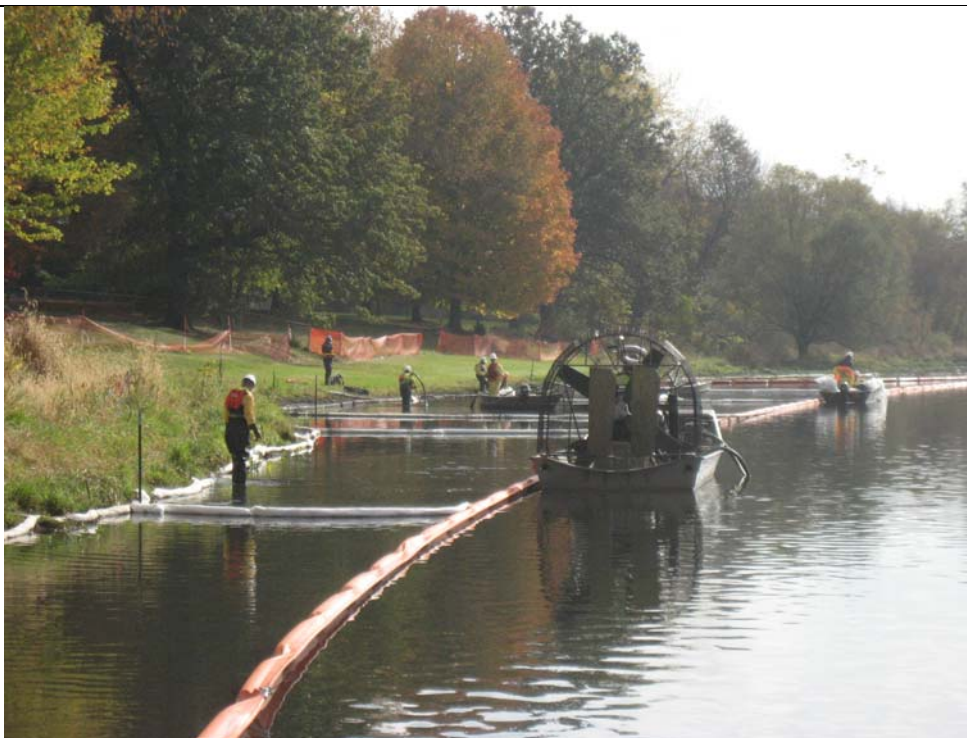
Description:
Recovery activities in
progress – water washing

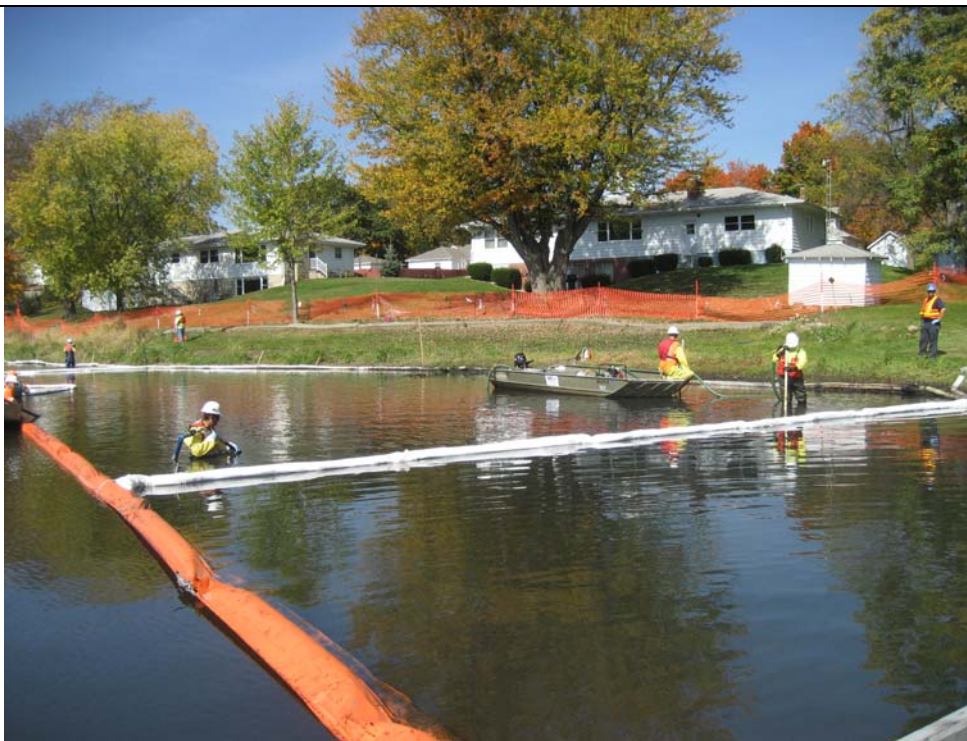
Photograph 2

Description:
Recovery activities in
progress - water washing

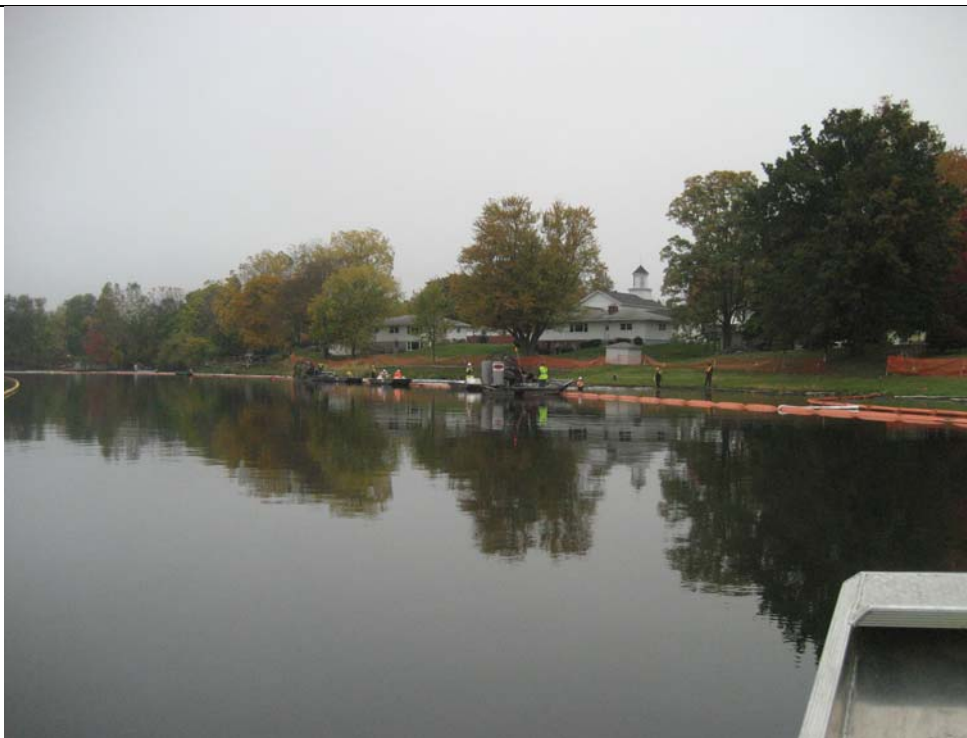
Photograph 3

Description:
Recovery activities in
progress – water washing

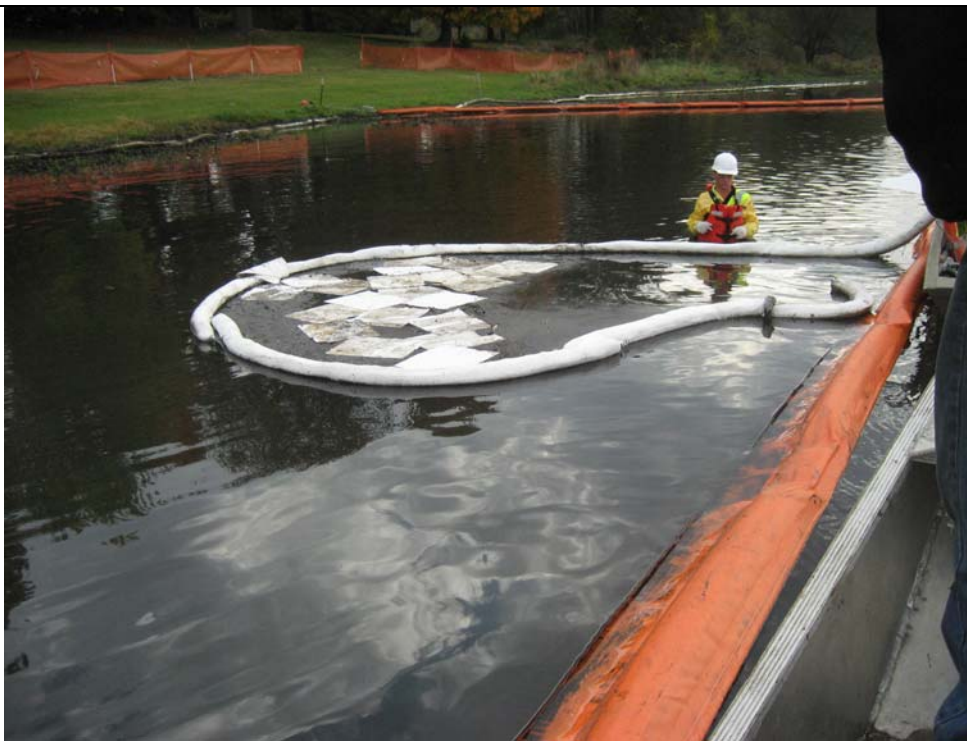
Photograph 4

Description:
Recovery activities in
progress – boom and pad
collection of oil

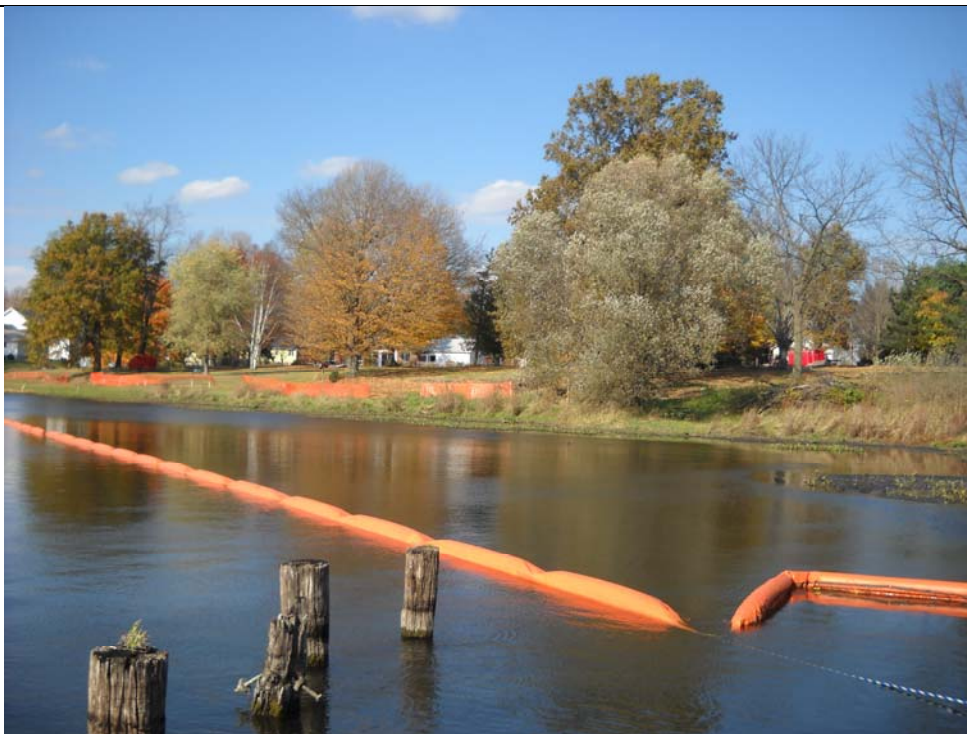
PHOTOGRAPH LOG
Photograph 5

Description:
Post Recovery - Aeration
and washing activities
complete

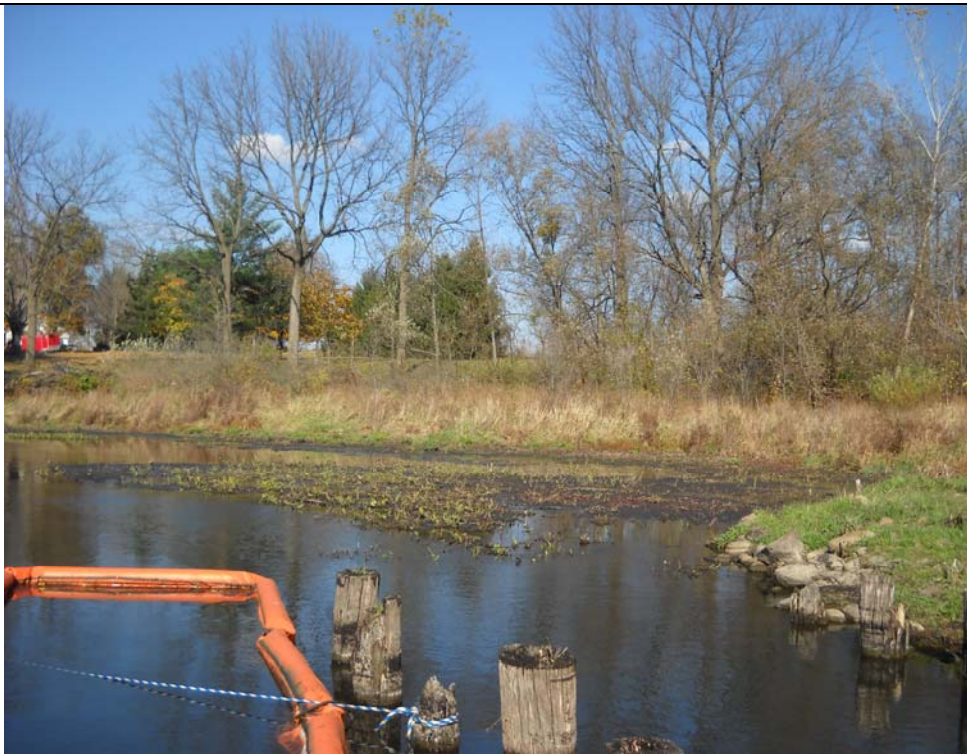
**PHOTOGRAPH LOG**
Photograph 6

Description:
Post Recovery - Aeration
and washing activities
complete

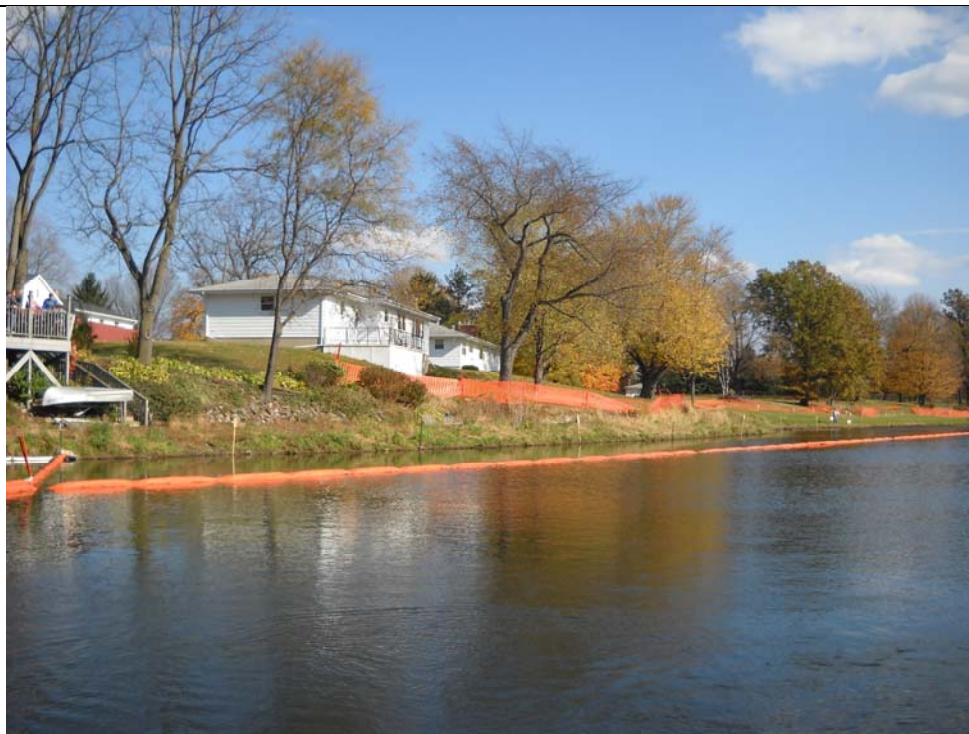
PHOTOGRAPH LOG
Photograph 7

Description:
Post Recovery - Aeration
and washing activities
complete

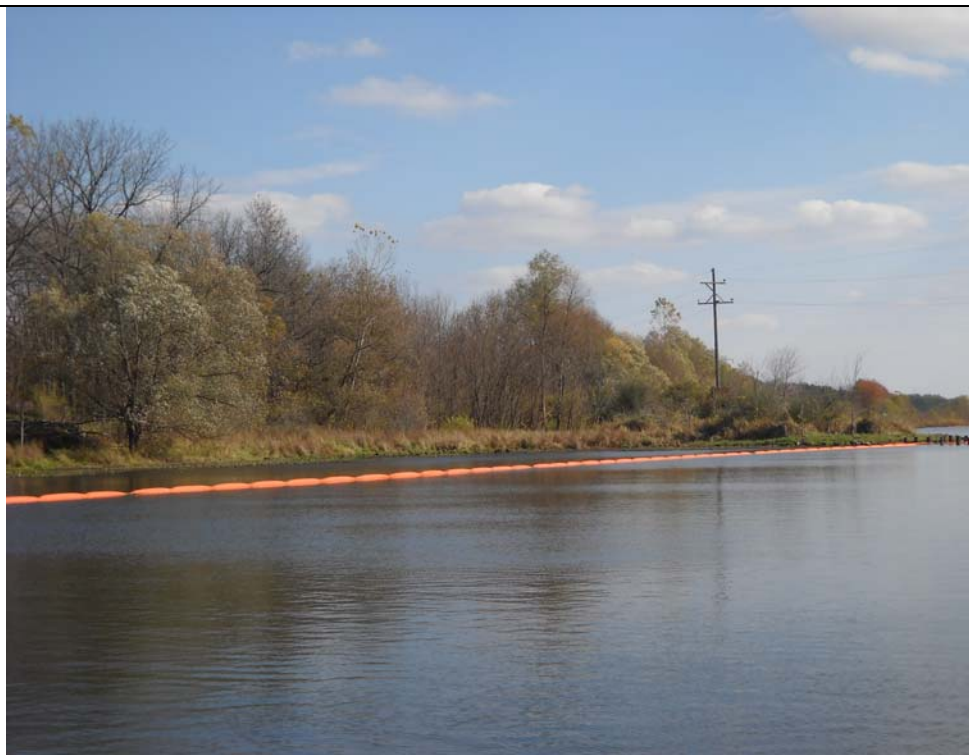
Description:
Post Recovery - Aeration
and washing activities
complete

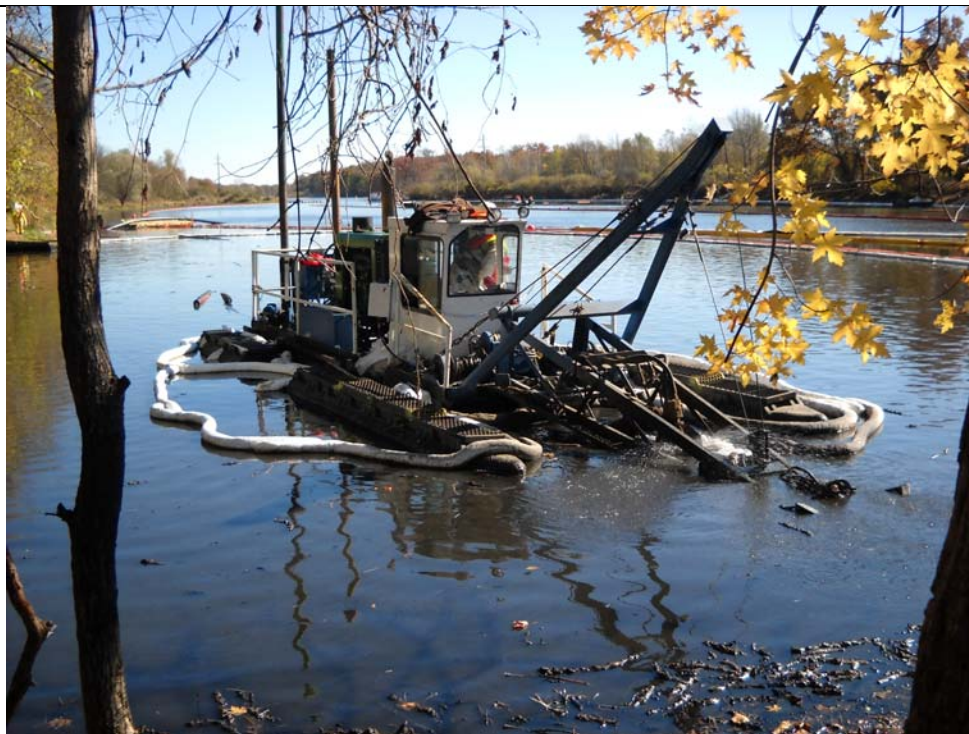
Description:
Recovery activities in progress – Dredging with cutter-head dredge unit

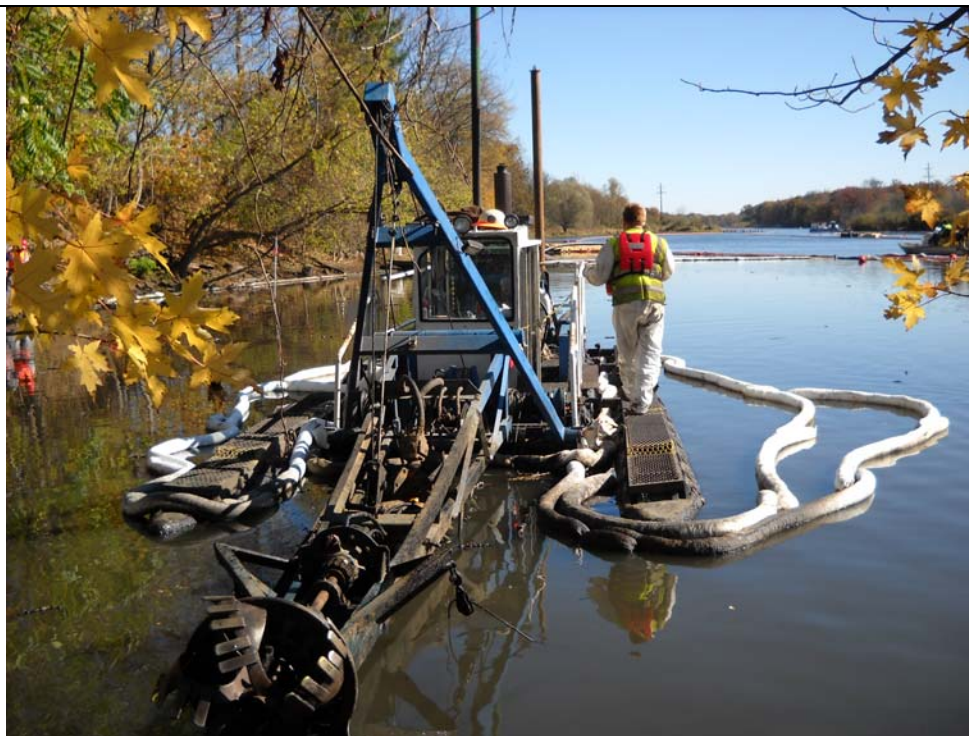
Photograph 2

Description:
Recovery activities in progress – Dredging with cutter-head dredge unit

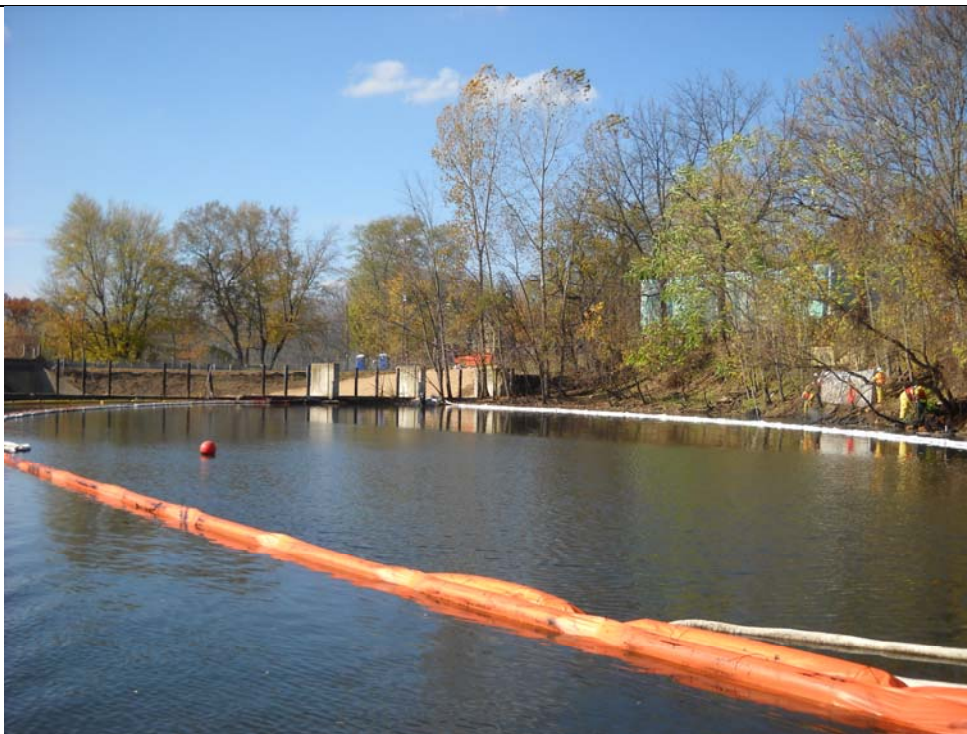
Photograph 3

Description:
Recovery activities
complete – Dredging
complete

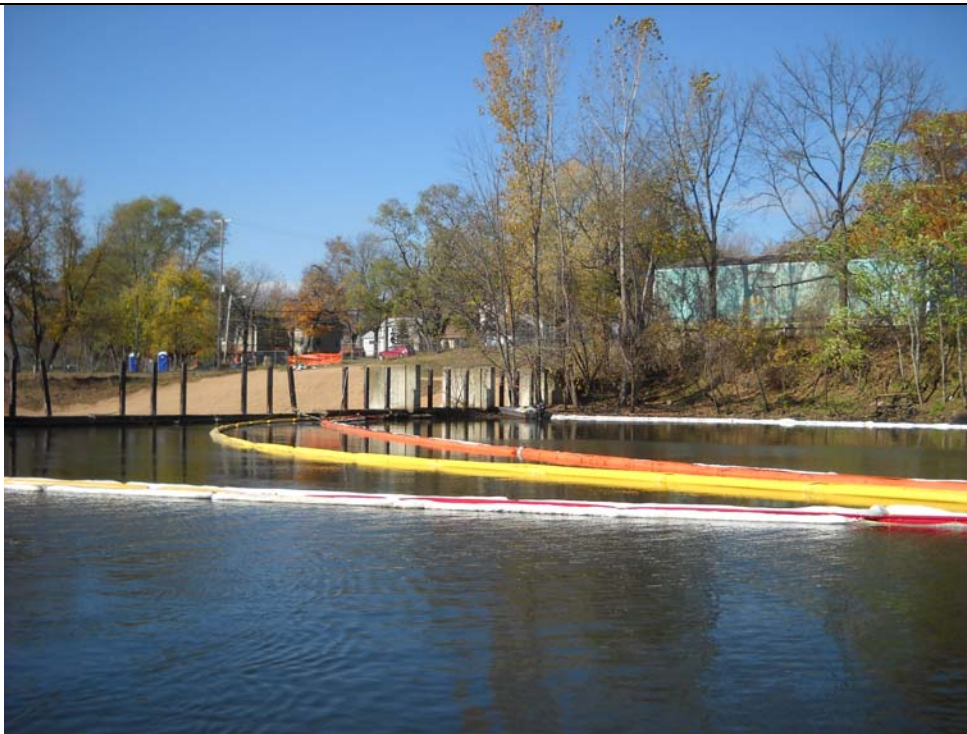
Photograph 4

Description:
Recovery activities
complete – Dredging
complete

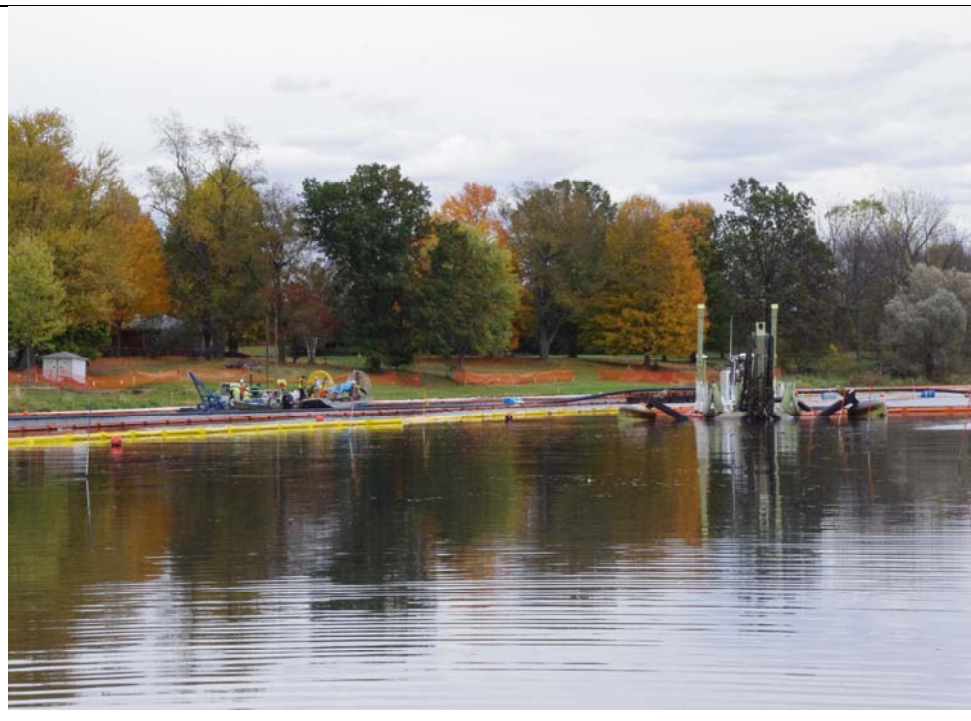
Description:
Recovery activities in
progress – Dredging with
Amphibex

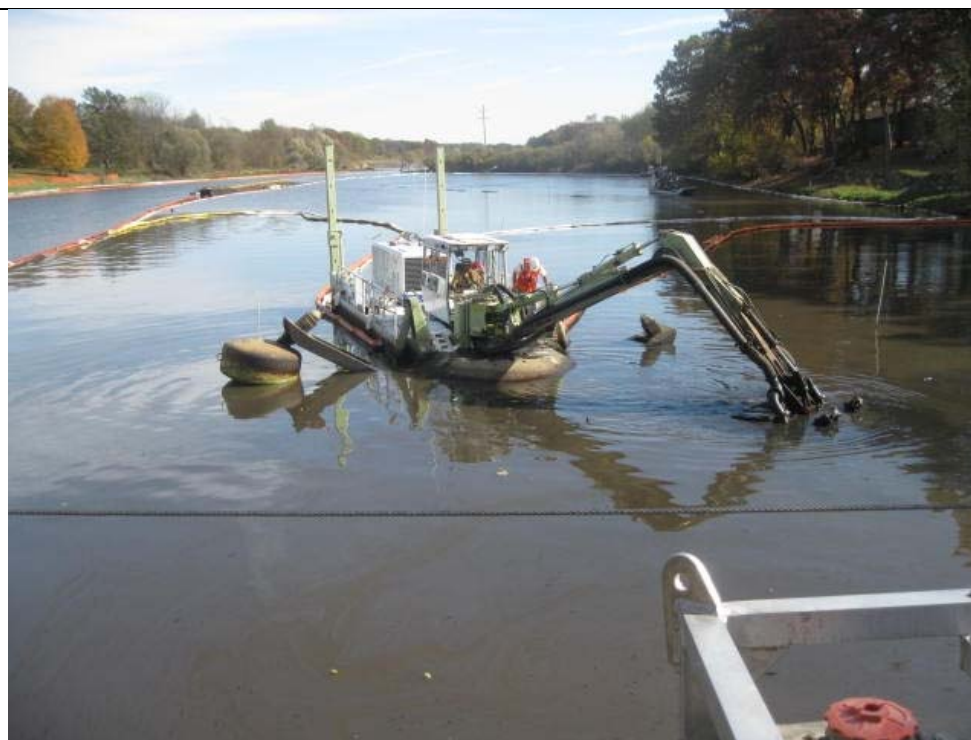
Photograph 2

Description:
Recovery activities in
progress – Dredging with
Amphibex

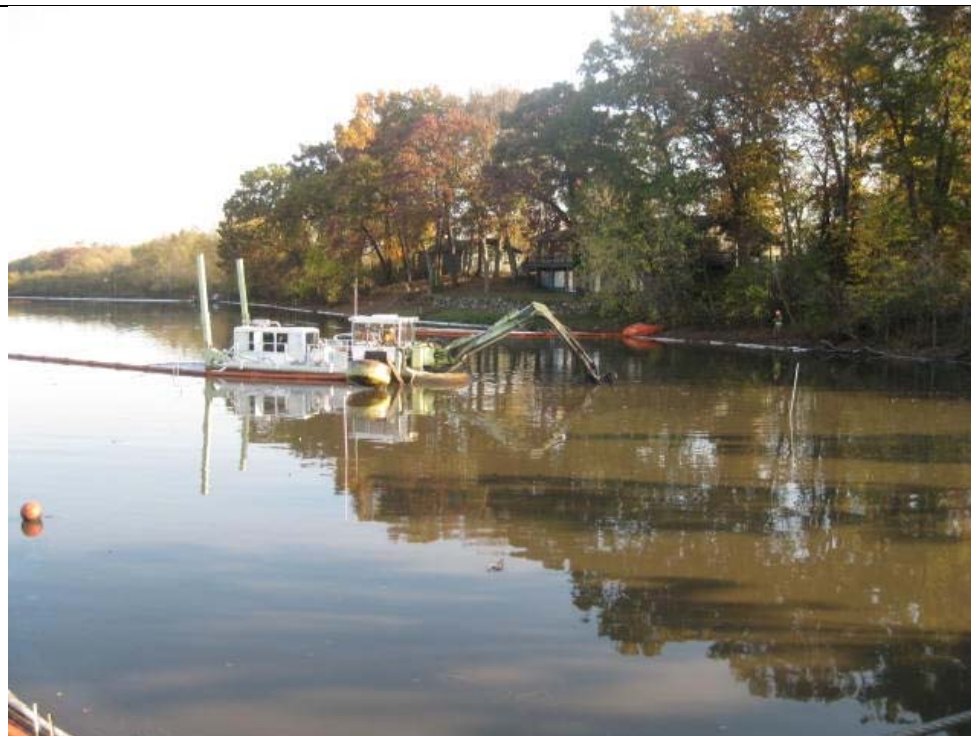
Photograph 3

Description:
Recovery activities in progress – Dredging with Amphibex

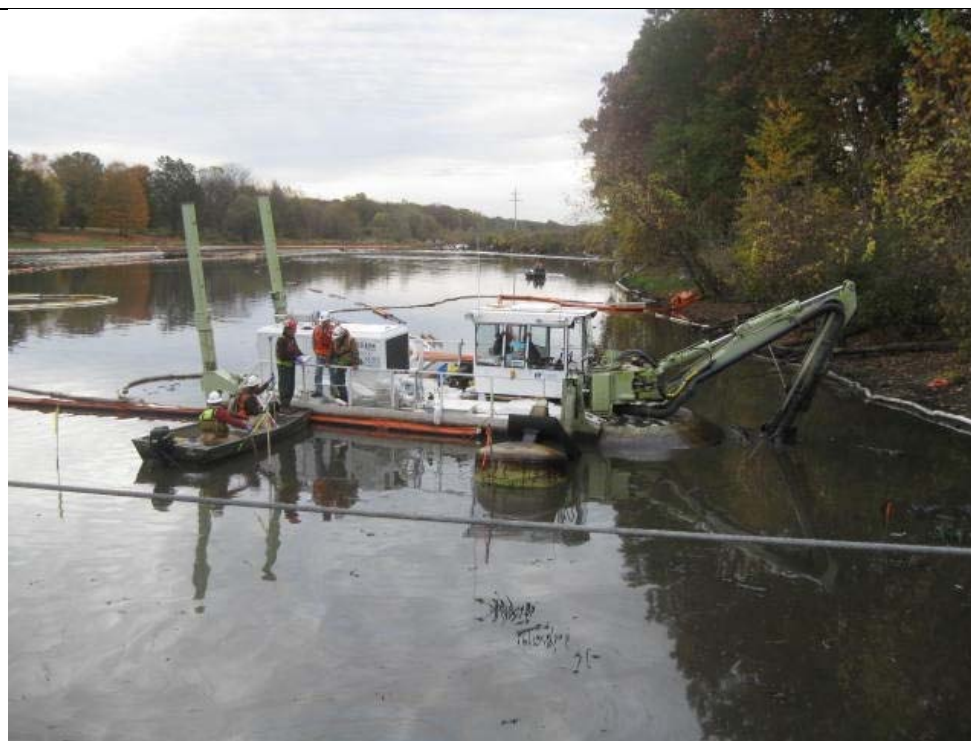
Photograph 4

Description:
Recovery activities in progress – Dredging with Amphibex

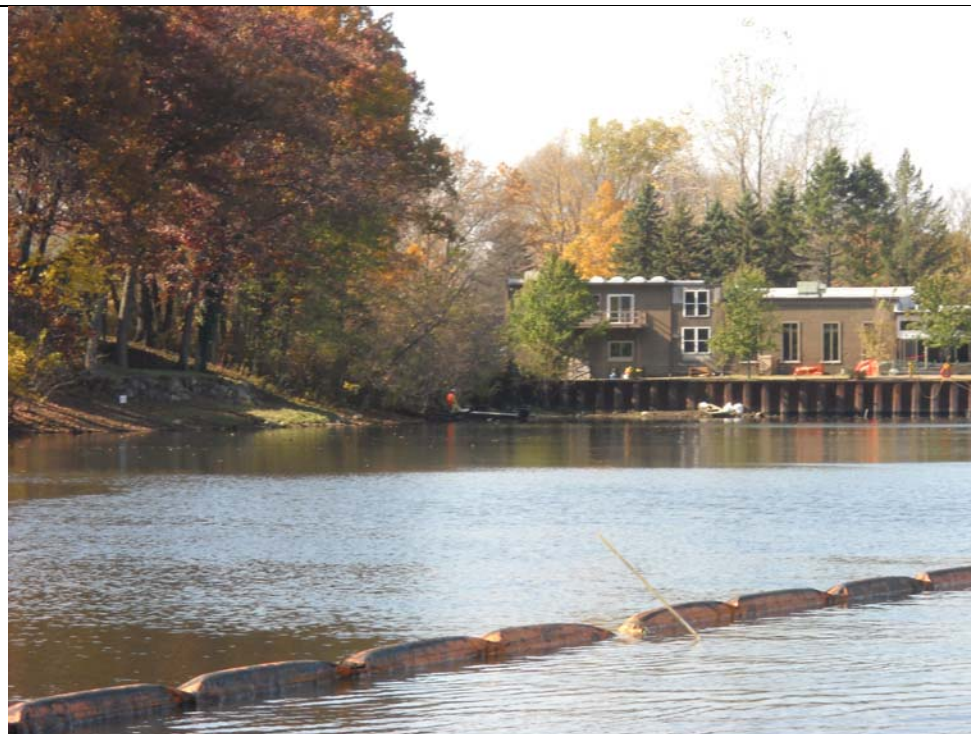
PHOTOGRAPH LOG
Photograph 5

Description:
Recovery activities
complete – dredging
completed
